# Rain Barrel Water Quality in South Florida<sup>1</sup>

Kimberly Moore, Mica McMillan, and Lorna Bravo<sup>2</sup>

<sup>1</sup> This document is ENH1376, one of a series of the UF/IFAS Department of Environmental Horticulture. Original publication date October 2023. Revised September 2026. Visit the Ask IFAS website at <https://ask.ifas.ufl.edu/> for the currently supported version of this publication.

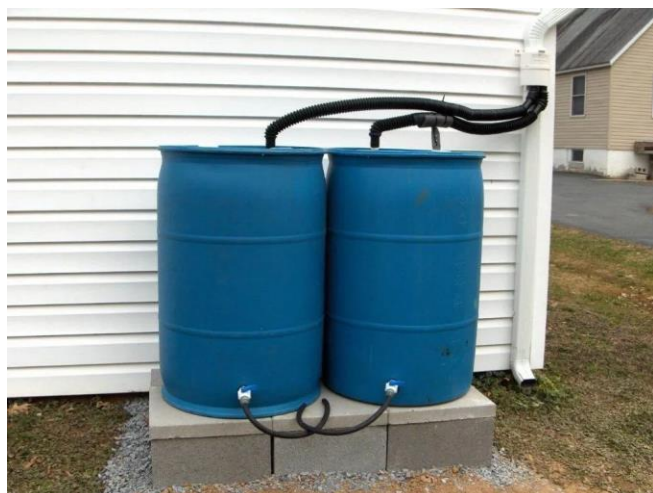
Figure 1. Rain barrel installation collecting from gutters.  
Credit: Kimberly Moore, UF/IFAS

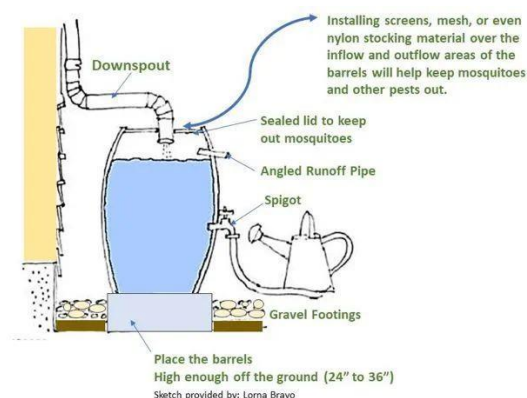
Figure 2. Diagram of connecting a rain barrel to a downspout.  
Credit: Lorna Bravo, UF/IFAS
